GeoSolutions, INC.

February 7, 2017
Project No. 10078-2

Subject: **Numerical Slope Stability Evaluation**
2535 Main Street
Cambria, California

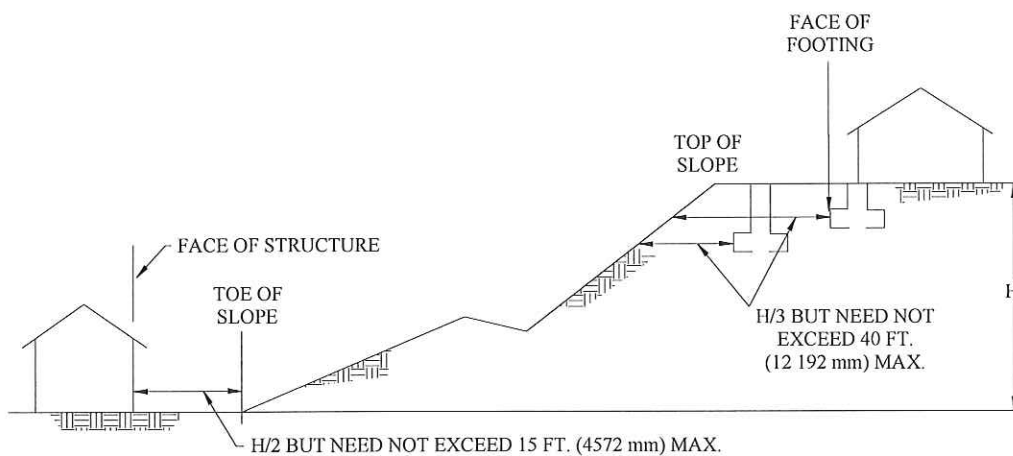
Figure 2: Building Setback Distance

1. The minimum building setback distance from ascending or descending slopes steeper than 3-to-1 (horizontal-to-vertical) but less than 1-to-1 must be maintained.

It is recommended that the buildings at the site maintain a setback distance of 15 feet from toe of slope if retaining structures are not utilized at the property. Figure 2 shows recommended setbacks.

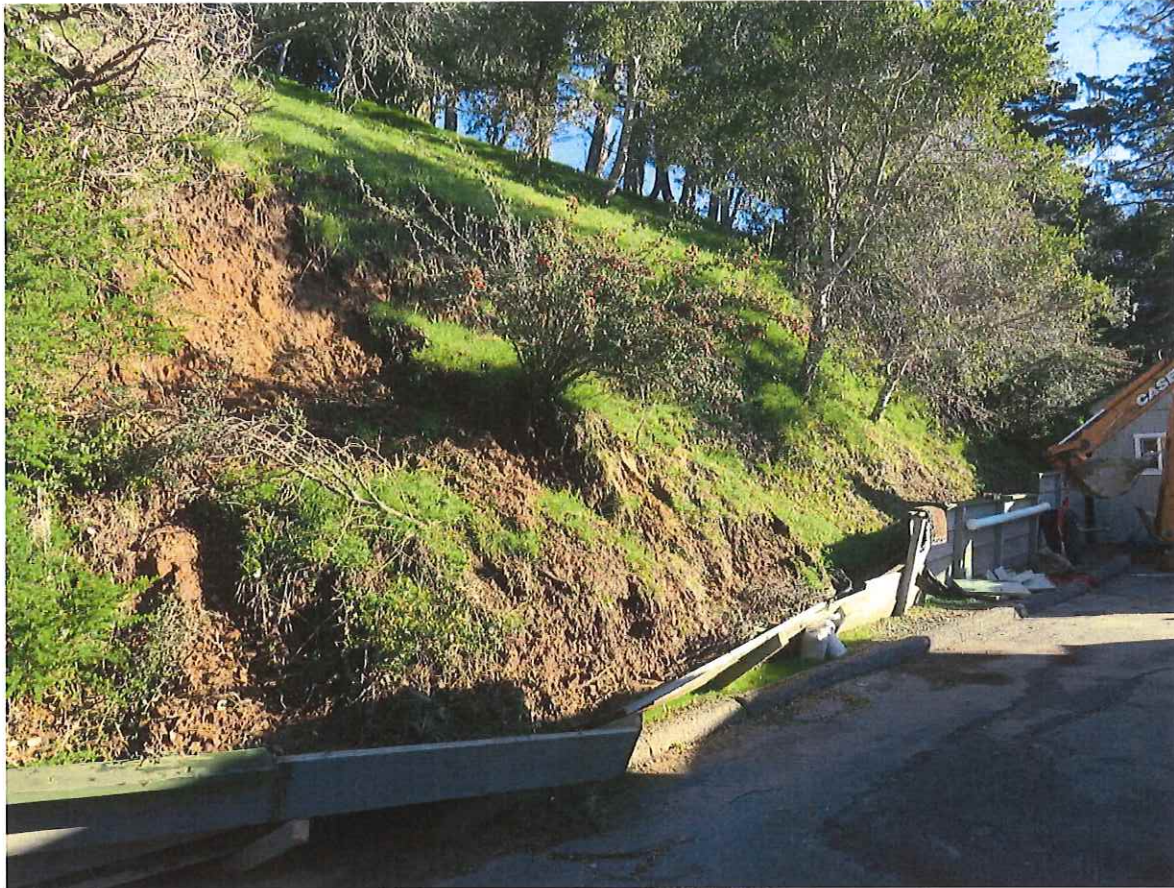
Figure 4: View northeast of failure of cut slope. Note proximity of building in back to cut slope and failure of wood wall. Trench T-1 was excavated near the building, Trench T-2 was excavated in the slide, and Trench T-3 was excavated just left of the sight of the picture.

In addition to the recent slope failure, buildings at the site are within close proximity of the cut slope. The building utilized by employees as sleeping quarters is only several feet from the existing cut slope. The potential for an unstable slope to affect this building is very high.

2. As slopes are unstable as currently cut, safety of personnel, equipment, and structures is paramount. It is recommended the small building utilized by personnel as a residence quarters, not be used until slopes can be retained or substantial distance (15 feet) from the building to the toe of slope can be maintained. K-rail is recommended to be installed within the driveway area that does not maintain a distance of 15 feet between the larger on-site building and failed slope as a temporary measure to reduce potential of failed slope material to affect the larger on-site building. Ambulances and other vehicles are recommended to NOT be parked behind the building until retaining structures can be constructed.

3. It is recommended that a civil engineer/general contractor with experience with cut slopes and retaining structures be contacted regarding types of retaining structures that can be established at the site where slopes exceed 2:1 (horizontal:vertical). In lieu of a poured concrete retaining wall, structures such as Redi-Rock stacked block wall may offer mitigation to retaining the slope. Graded options may be considered however, cuts within colluvial material (surface soils) and weathered rock must maintain a maximum slope gradient of 2:1 (horizontal:vertical) or less steep.

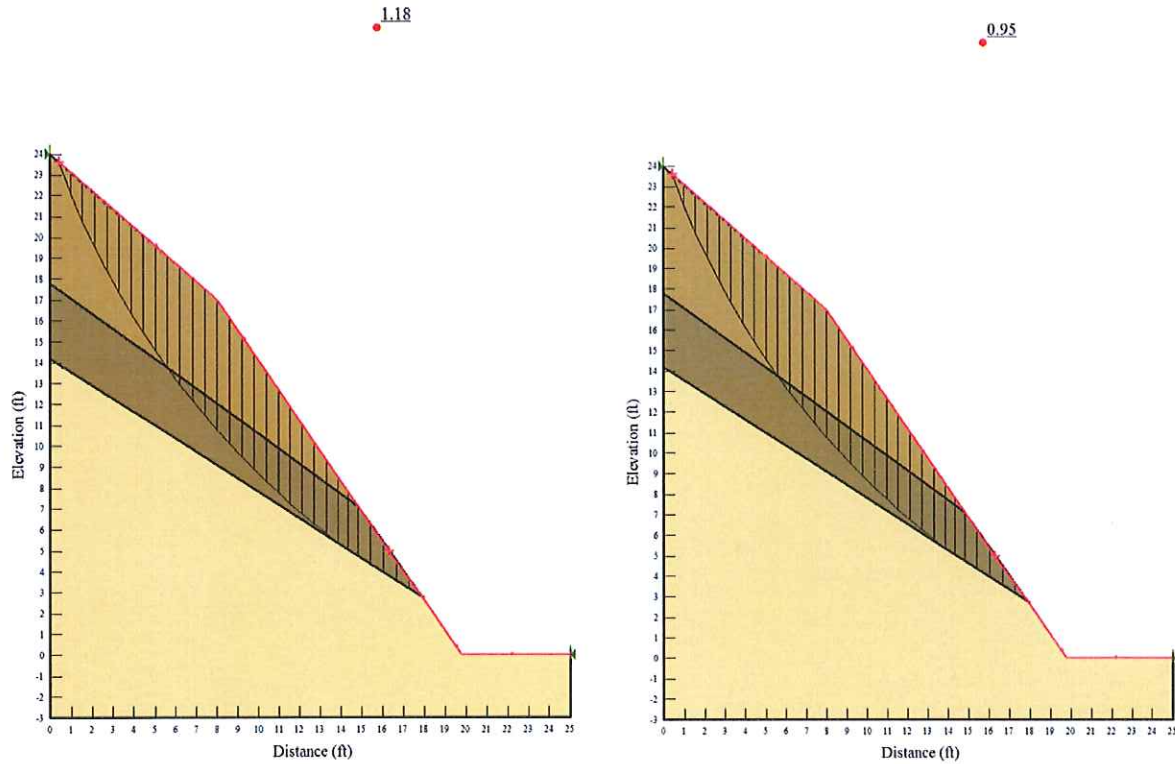
The static stability analyses performed for the existing cut slope configurations as encountered at the site with material collected from three trenches (within the cut slope) shows that the **critical static factor of safety values are below the minimum standard, indicating that they reflect unstable conditions as the slope is now configured.** The minimum engineering standard for static factors of safety is 1.5.

The pseudo-static (seismic) stability analyses performed for the slope configurations shows the **critical pseudo-static factor of safety values are below the minimum standard (1.15), indicating that they reflect unstable conditions.**

Figure 5: Trench T-1, (Static, value of 1.18, pseudo-static value of 0.95)

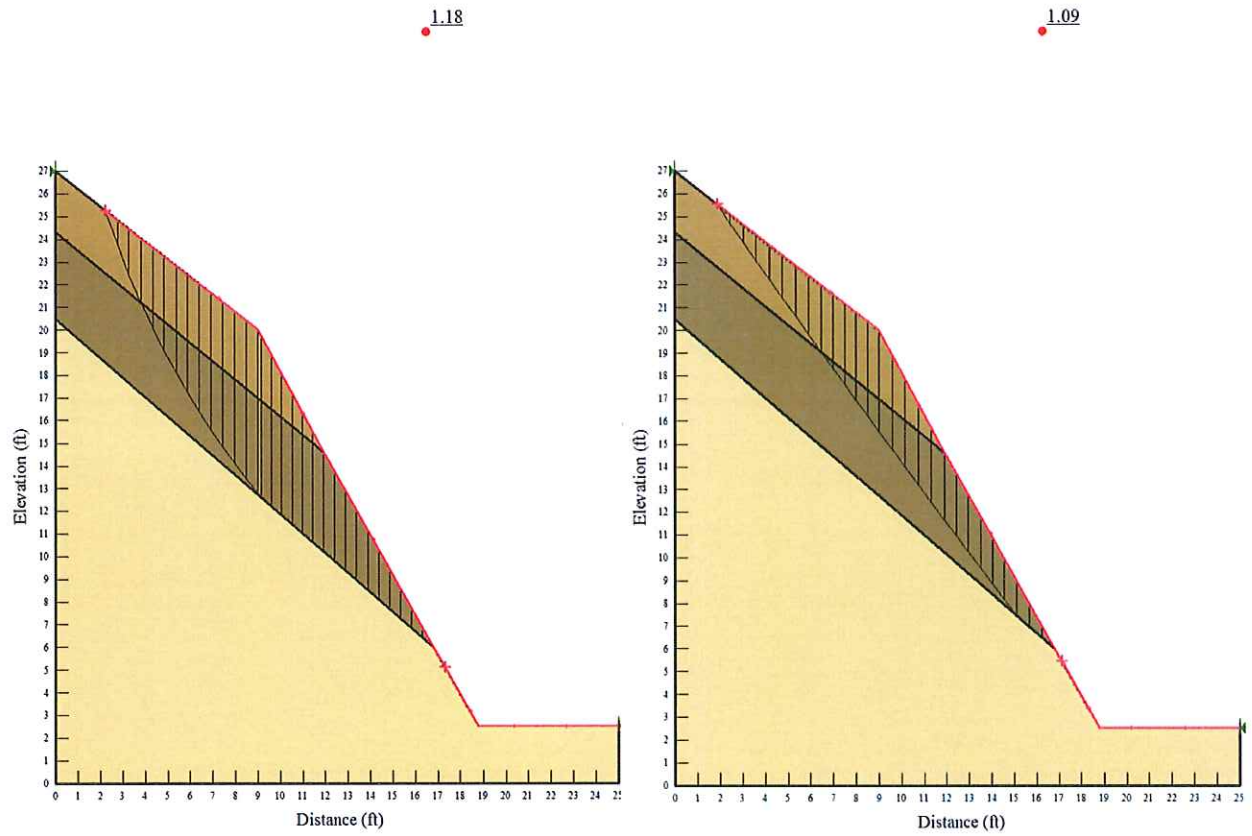
Figure 6: Trench T-2 (Static, value of 1.18, pseudo-static value of 1.09)

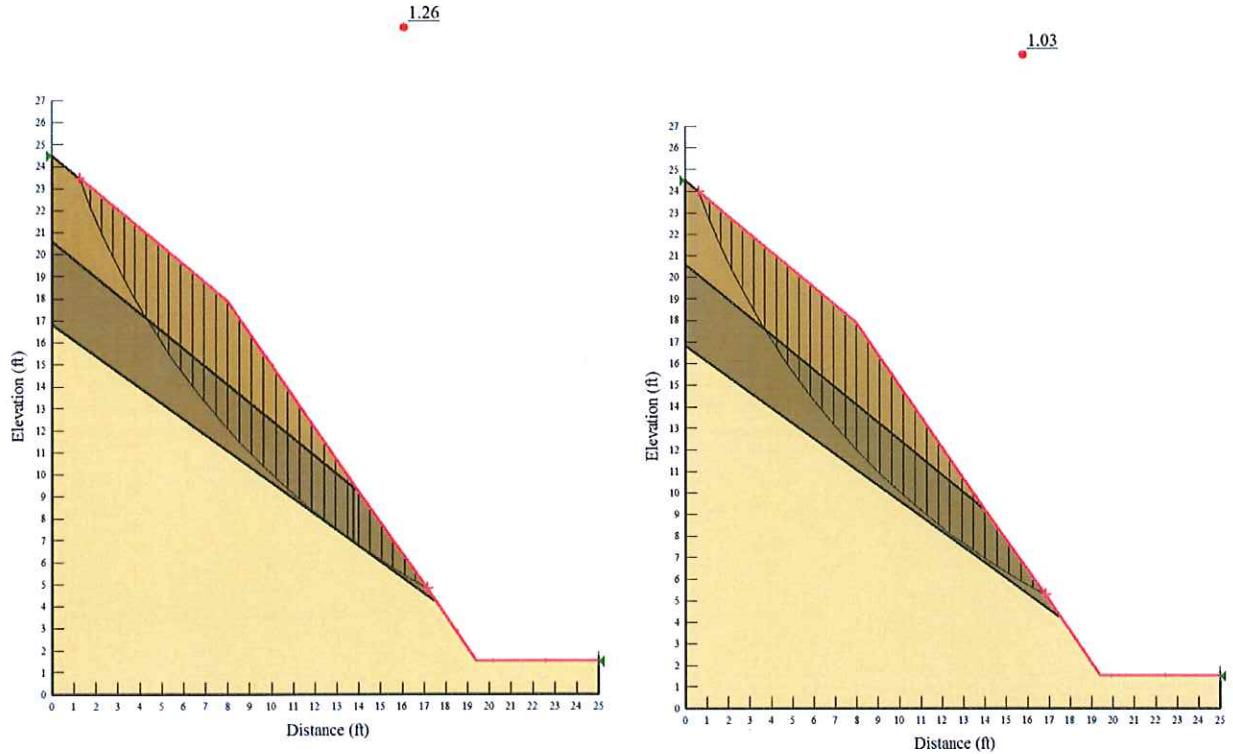
Figure 7: Trench T-3 (Static, value of 1.26, pseudo-static value of 1.03)

Based on the results of the analysis, the cut slope is not stable the current configuration (static values less than 1.5 or pseudo-static values less than 1.15).
