CAMBRIA COMMUNITY HEALTHCARE DISTRICT

Property & Facilities Committee MEETING

Cambria Community Healthcare District
Facility Condition Assessment

CCHD Offices and Ambulances

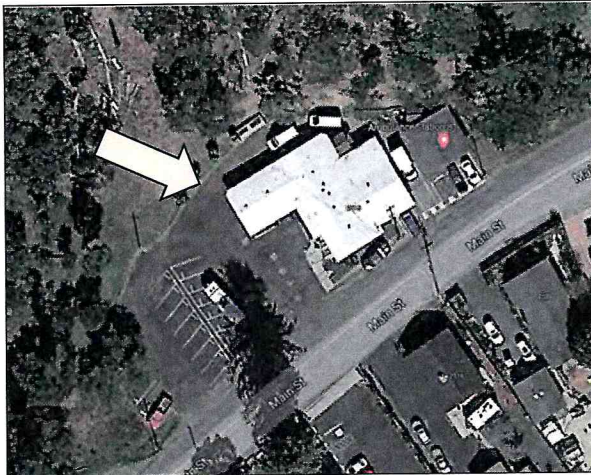
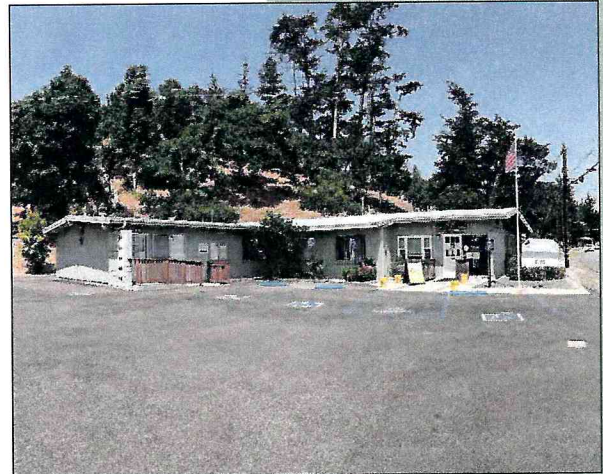
Address: 2511 Main Street, Cambria
Year Built: 1955 with additions in 1967

No. of Stories: 1
Square Feet: 3,800

Facility Summary Observations: The CCHD facilities include two larger buildings and several small relatively temporary outbuildings. The main building contains the CCHD offices, tenant space (CHC), and crew quarters. The other larger building (the ambulance building) is no longer in use, has been red tagged by the County, and is intended to be demolished. This evaluation only includes assessment of the primary building.

Overall, the facility is in very poor condition, primarily related to its age. Most building systems are either original or well beyond their normal useful life expectancy. Based on our assessment of the facility the following issues and deficiencies were identified with the following major components and systems.
