GeoSolutions, INC.

February 7, 2017
Project No. 10078-2

Subject: **Numerical Slope Stability Evaluation**
2535 Main Street
Cambria, California

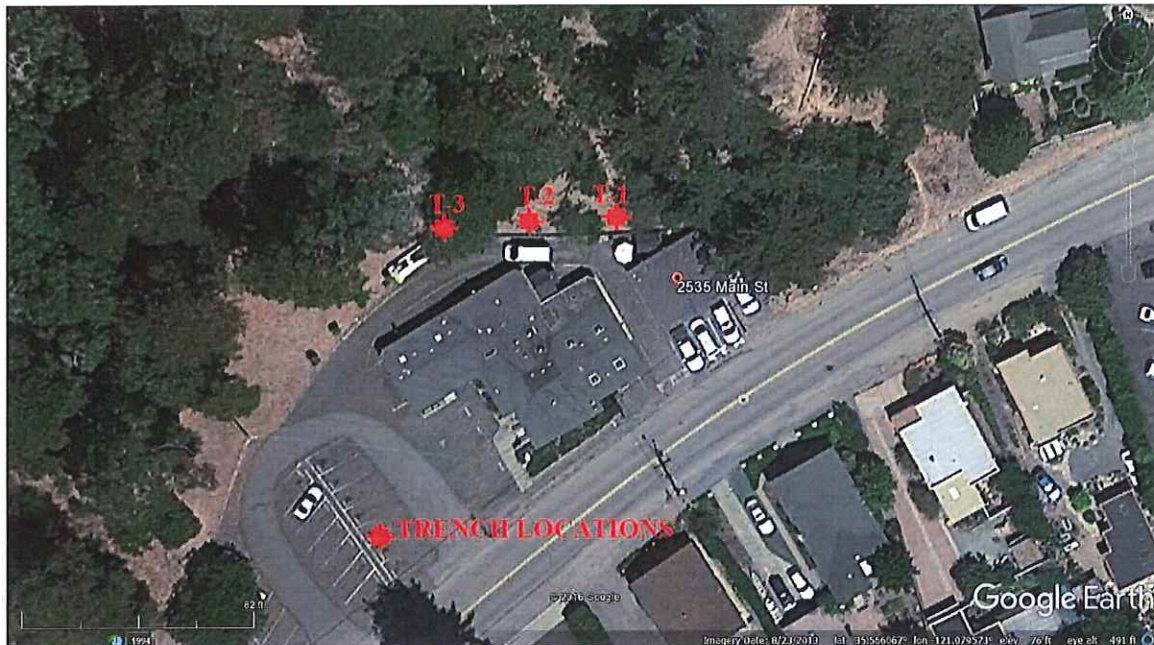
Figure 3: Site Aerial with Trench Locations

The subject property is located in the community of Cambria, California along the north side of Main Street. The property maintains a relatively flat area on the southern portion of the property where a parking lot and two buildings are situated. One building is utilized as a health center, the other building is utilized as housing for medical personnel. A slope rises along the northern portion of the property that extends beyond the property boundary. A recent slope failure prompted the undersigned to assess the slope as it is currently configured. No site topographic map or site map was available for this investigation. Figure 3 depicts an aerial photograph of the site and trenching locations. Figure 4 depicts the failed slope at the site.

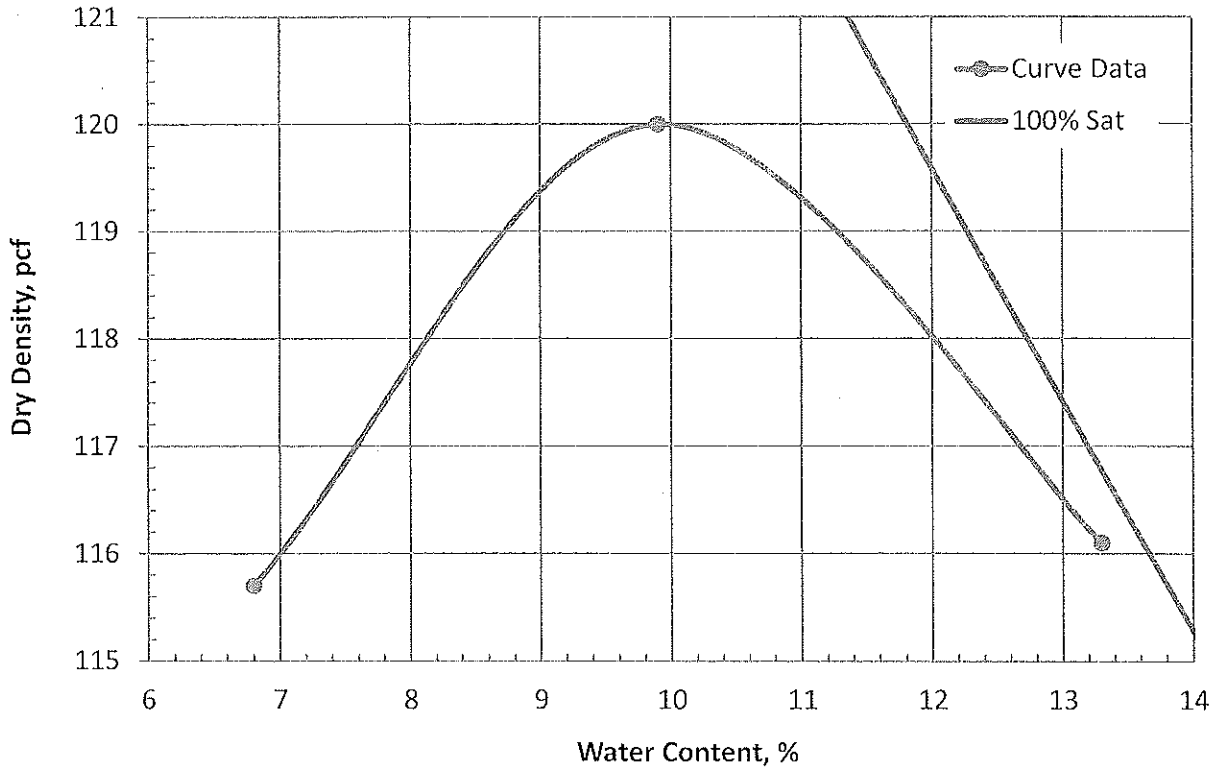
Project:	2535 Main Street - Cambria	Date Tested:	January 30, 2017
Client:		Project #:	SL10078-2
Sample #:	A	Depth:	2.0 Feet
Source:	T-1	Lab #:	16778
Material:	Olive Brown Silty SAND	Sample Date:	January 25, 2017
		Sampled By:	JK

ASTM Test Designation: D 698 D 1557
 Method (sieve size): A (#4) B (3/8") C (3/4")
 % Passing, Pf: _____ % Retained, Pc: _____ Estimated Measured
 Type of Rammer: Mechanical Manual
 Preparation Method Moist Dry
 100% Saturation Curve-Estimated Gs: 2.48

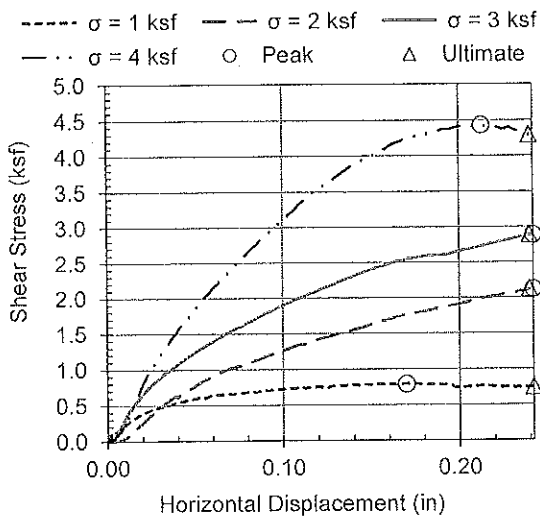
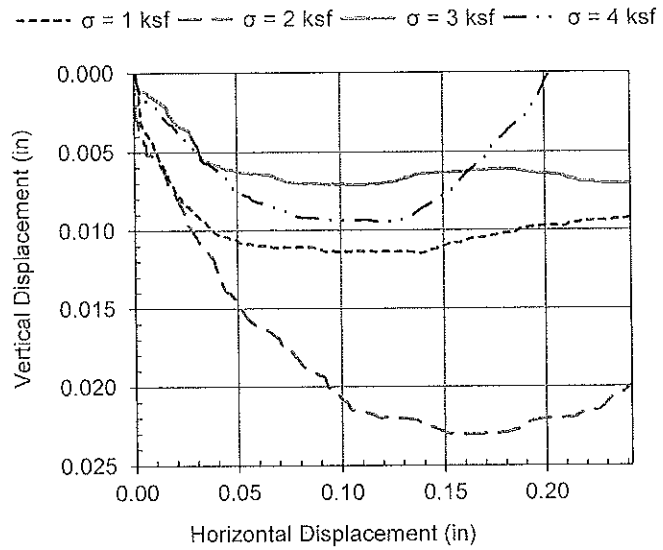
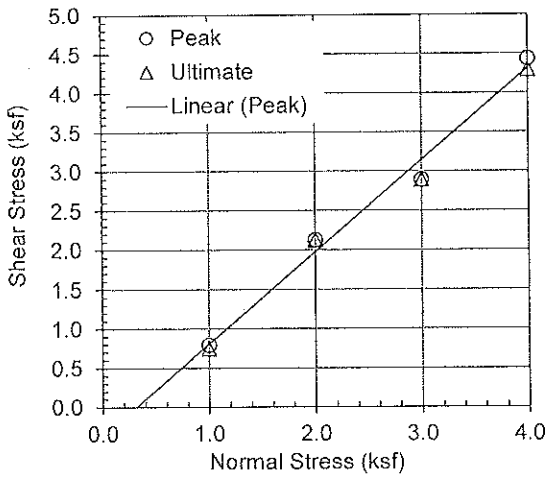
MATERIAL DESCRIPTION	LL	PL	PI	% passing No. 200	G _s *	Sample Type
Olive Brown Silty SAND	nm	nm	nm	nm	2.48	in-situ (rings)

Initial Conditions	Specimen No.			
	1	2	3	4
Dry Density	112.9	112.9	116.2	116.4
Water Content (%)	7.2	7.2	7.2	7.2
Diameter (in)	2.42	2.42	2.42	2.42
Sample Height (in)	1.00	1.00	1.00	1.00

Test Data	Specimen No.			
	1	2	3	4
Normal Stress (ksf)	1.00	2.00	3.00	4.00
Peak Shear Stress (ksf)	0.79	2.12	2.89	4.43
Horiz. Displacement at Peak Shear (in)	0.17	0.24	0.24	0.21
Ultimate Shear Stress (ksf)	0.74	2.12	2.89	4.29
Horiz. Displ. at Ult. Shear (in)	0.24	0.24	0.24	0.24
Rate of Deformation (in/min)	0.024	0.024	0.024	0.024

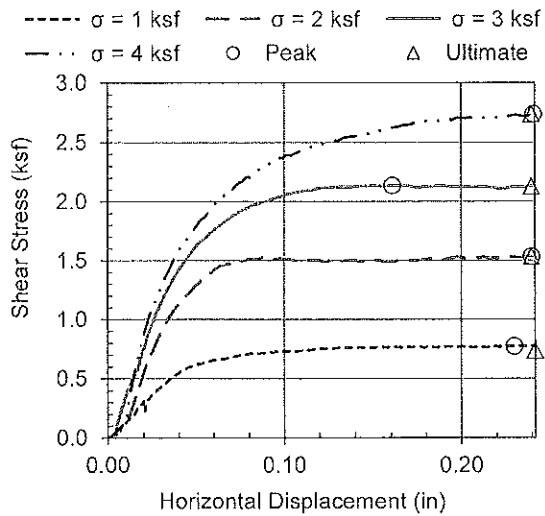
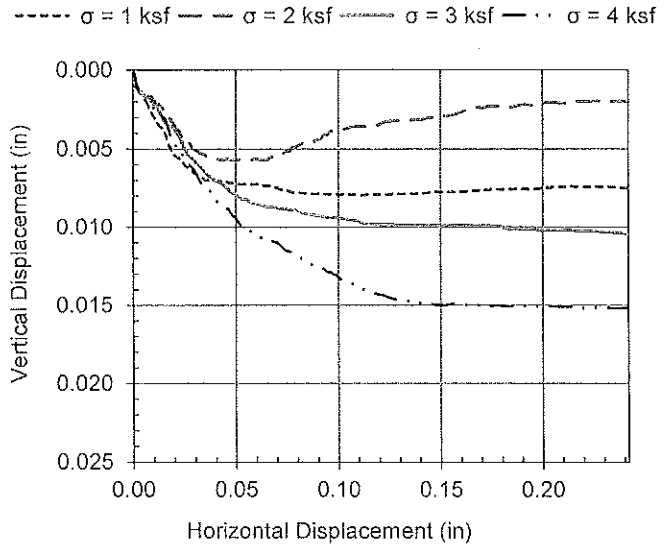
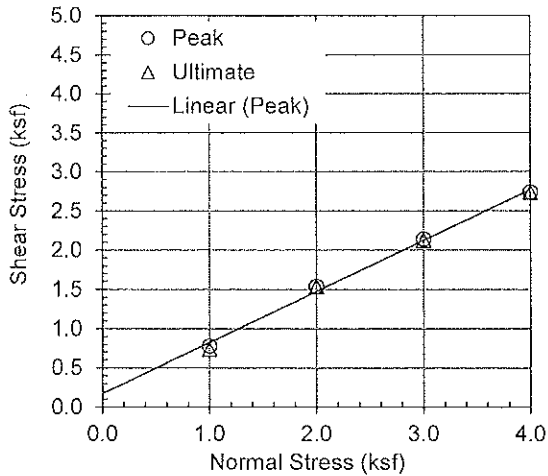
MATERIAL DESCRIPTION	LL	PL	PI	% passing No. 200	Gs *	Sample Type
Olive Brown Clayey SAND with Gravel	nm	nm	nm	nm	2.57	in-situ (rings)

Angle of Internal Friction, ϕ_{peak} (degrees):	33.0
Cohesion, C_{peak} (psf)	174

Initial Conditions	Specimen No.			
	1	2	3	4
Dry Density	106.3	106.3	106.3	106.3
Water Content (%)	11.9	11.9	11.9	11.9
Diameter (in)	2.42	2.42	2.42	2.42
Sample Height (in)	1.00	1.00	1.00	1.00

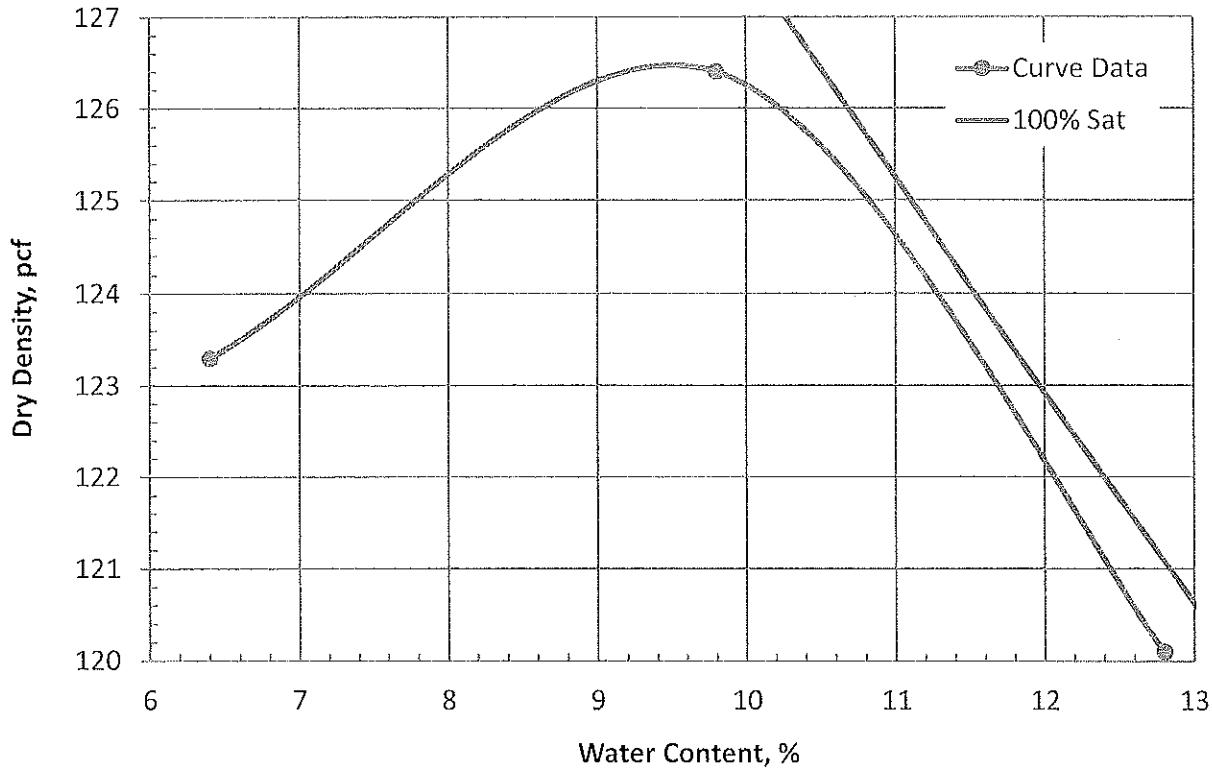
Project:	2535 Main Street - Cambria	Date Tested:	January 30, 2017
Client:		Project #:	SL10078-2
Sample #:	B	Depth:	8.0 Feet
Source:	T-1	Lab #:	16778
Material:	Olive Brown Clayey SAND with Gravel	Sample Date:	January 25, 2017
		Sampled By:	JK

ASTM Test Designation: D 698 D 1557
Method (sieve size): A (#4) B (3/8") C (3/4")
% Passing, Pf: _____ *% Retained, Pc:* _____ Estimated Measured
Type of Rammer: Mechanical Manual
Preparation Method Moist Dry
100% Saturation Curve-Estimated Gs: 2.57
